Evaluation of the Energy Performance and Design Process of the Thermal Test Facility at the National Renewable Energy Laboratory

P. Torcellini, S. Pless, B. Griffith, and R. Judkoff

National Renewable Energy Laboratory
1617 Cole Boulevard, Golden, Colorado 80401-3393
303-275-3000 • www.nrel.gov

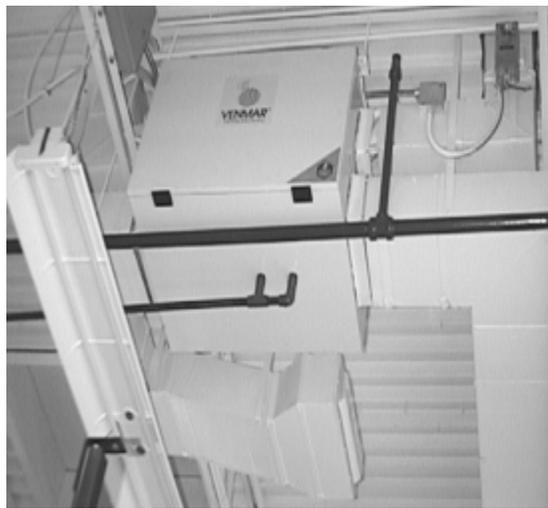
Figure 4-17 Air-to-air heat exchanger removes air from restrooms and kitchen and provides fresh air to building

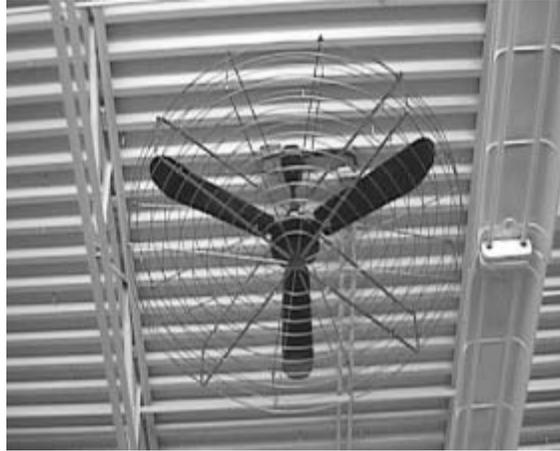
Figure 4-18 Ceiling fans destratify the air without using the main air-handler

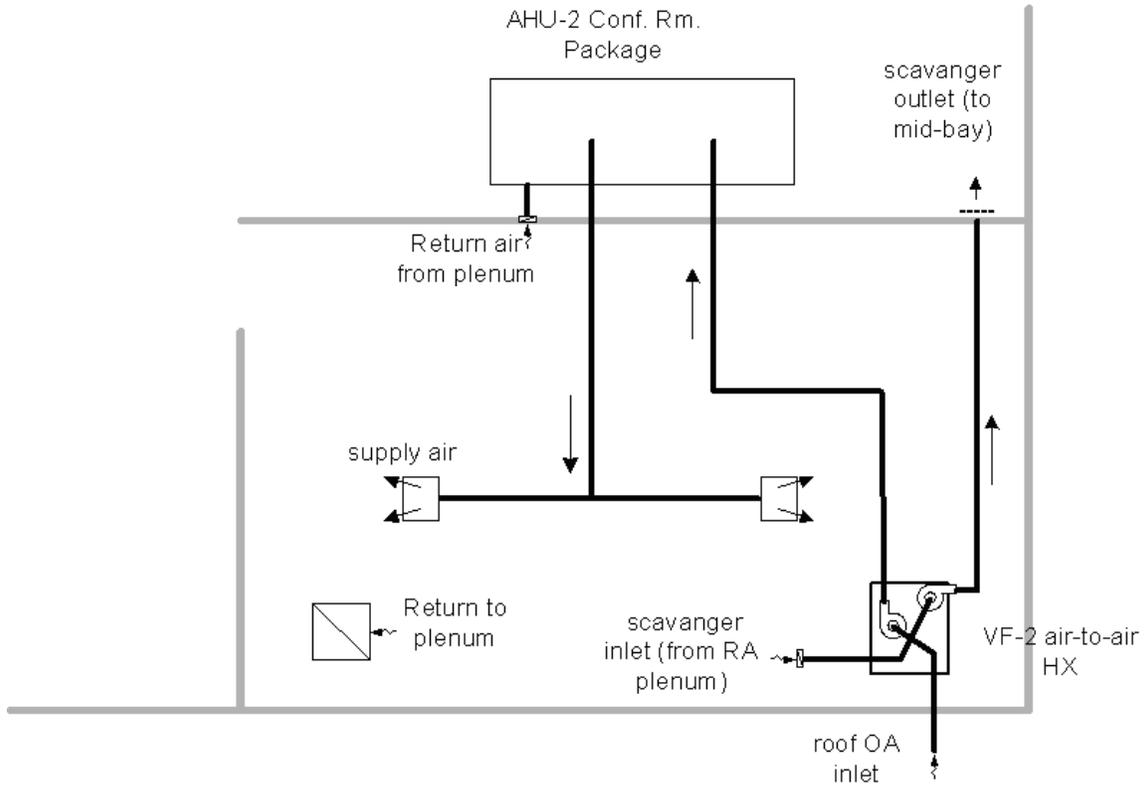
Figure 4-19 Conference room HVAC schematic

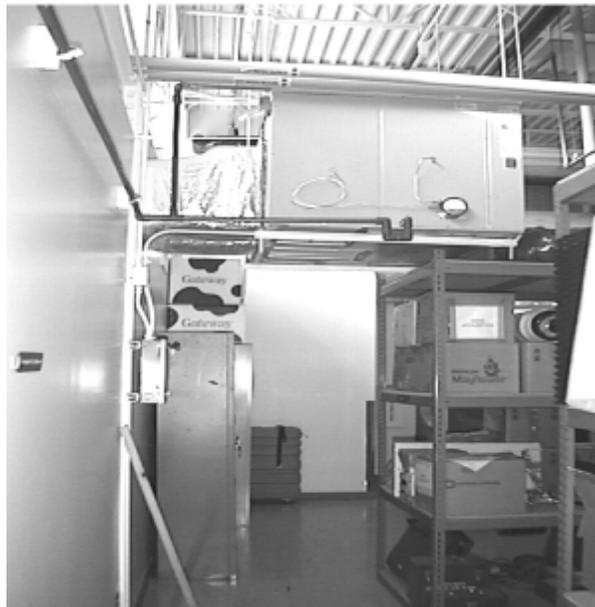
Figure 4-20 Conference room rooftop packaged system (located indoors)

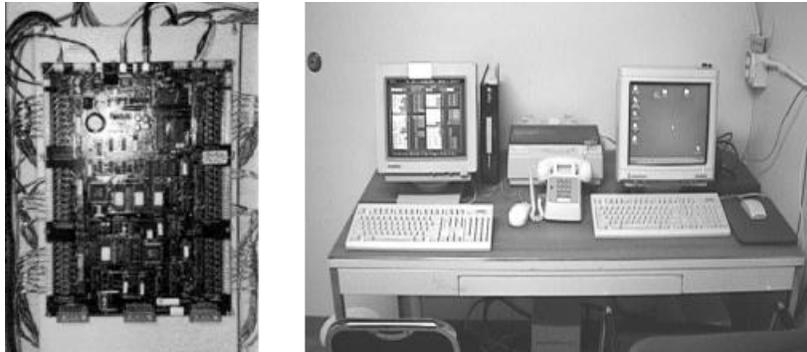
Figure 4-21 EMS input/output panel (left) with PC interface (right)

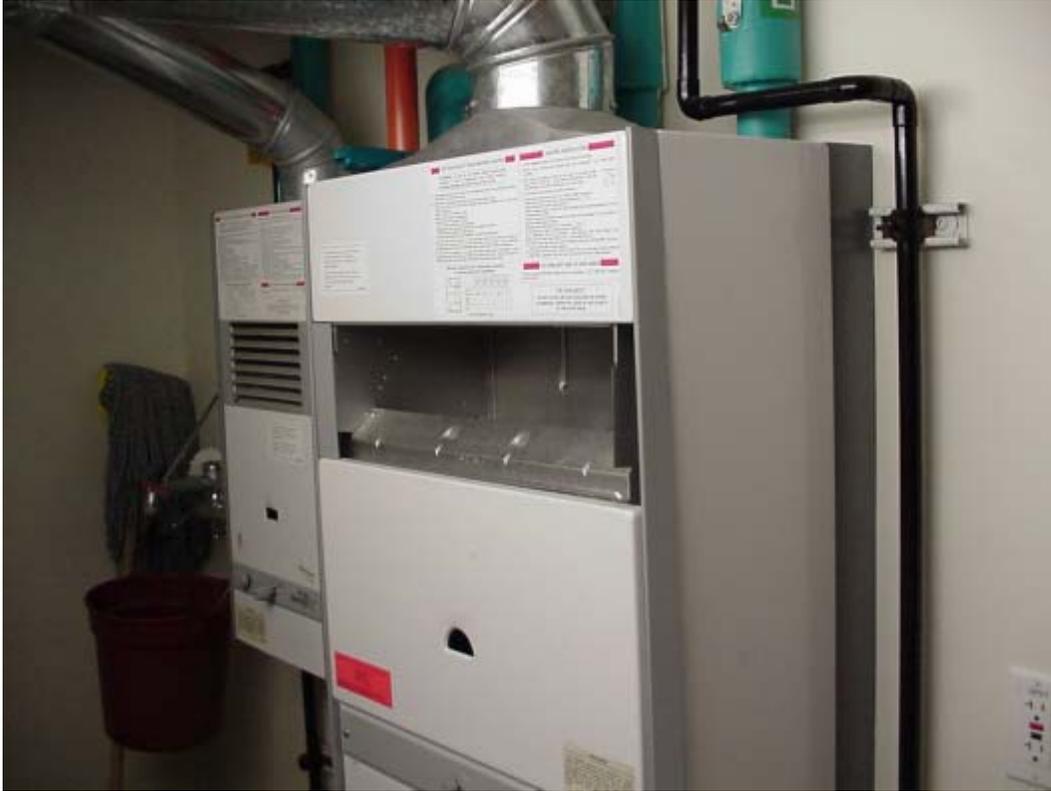
Figure 4-22 Tankless DHW heaters

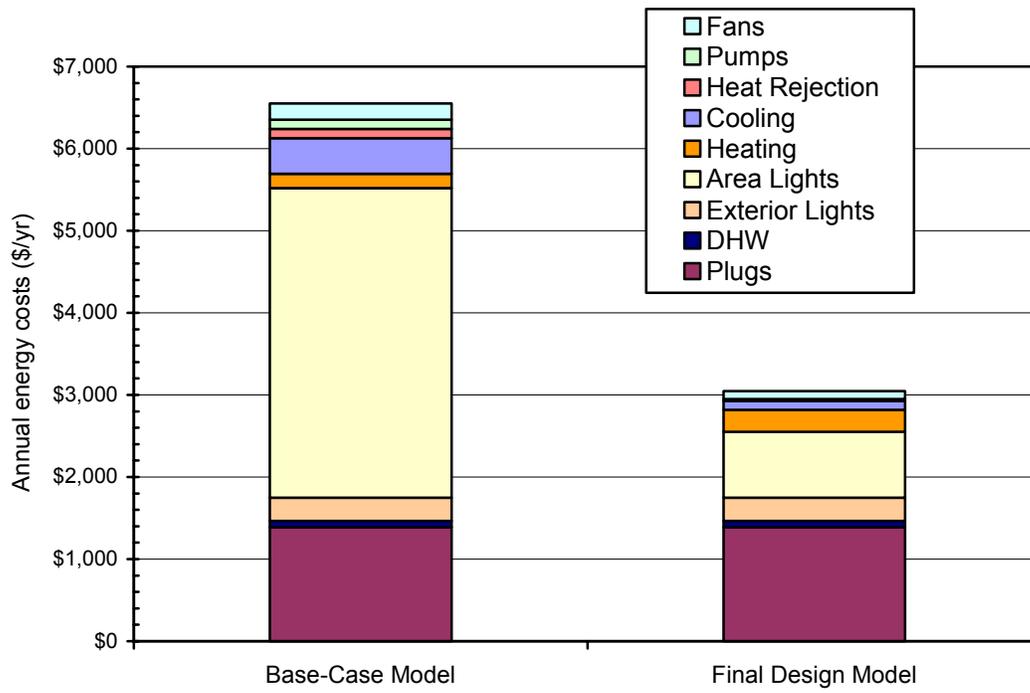
Figure 4-24 Summary of results for energy costs: final design model versus base-case model

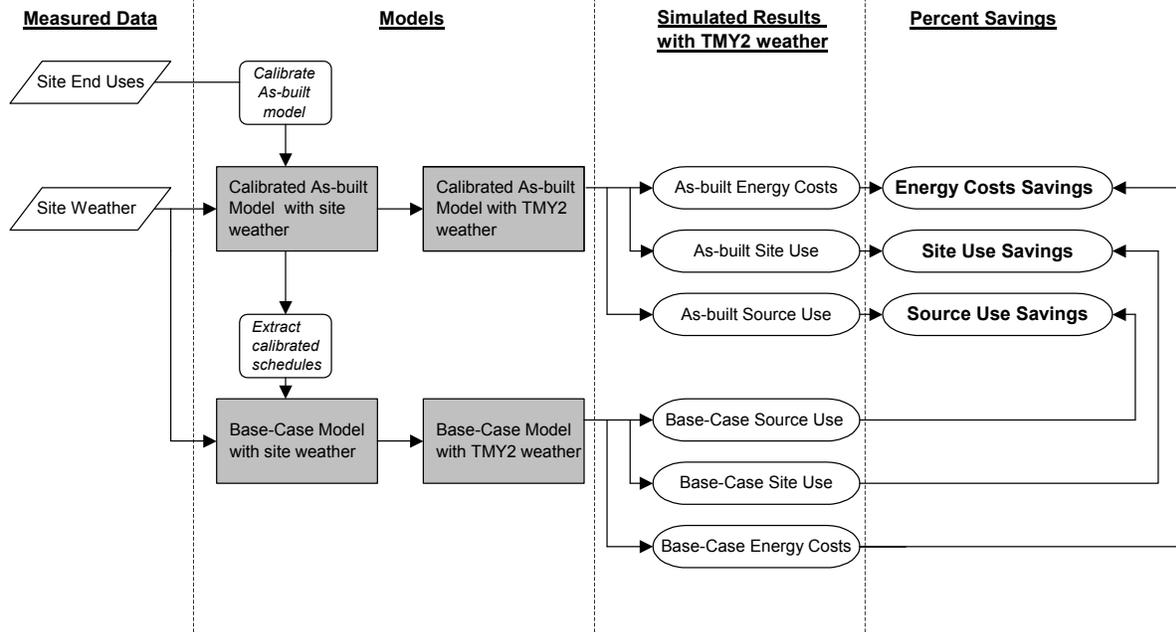
Figure 5-1 Whole-building evaluation flow chart

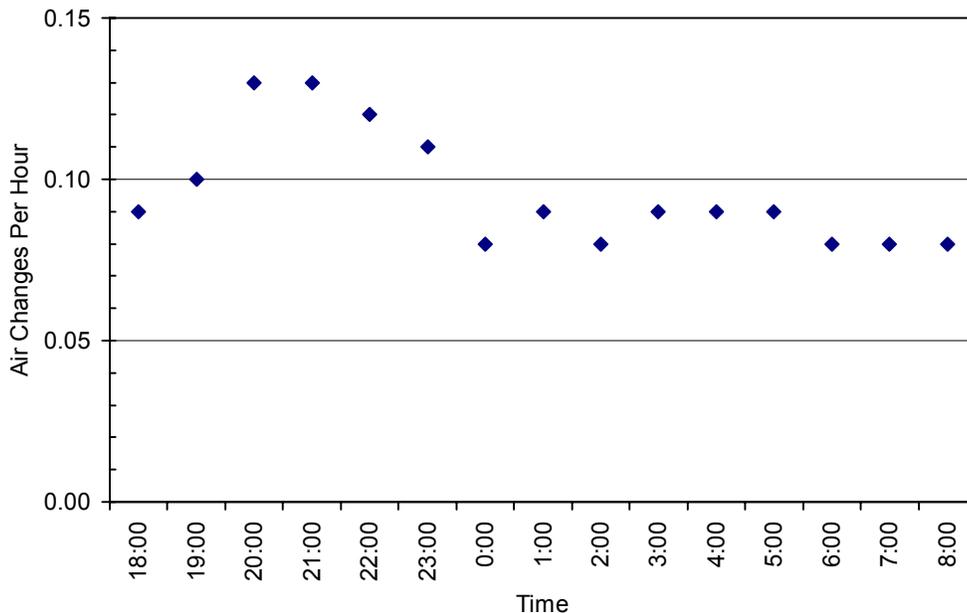
Figure 5-2 Results from tracer gas measurement of infiltration rate

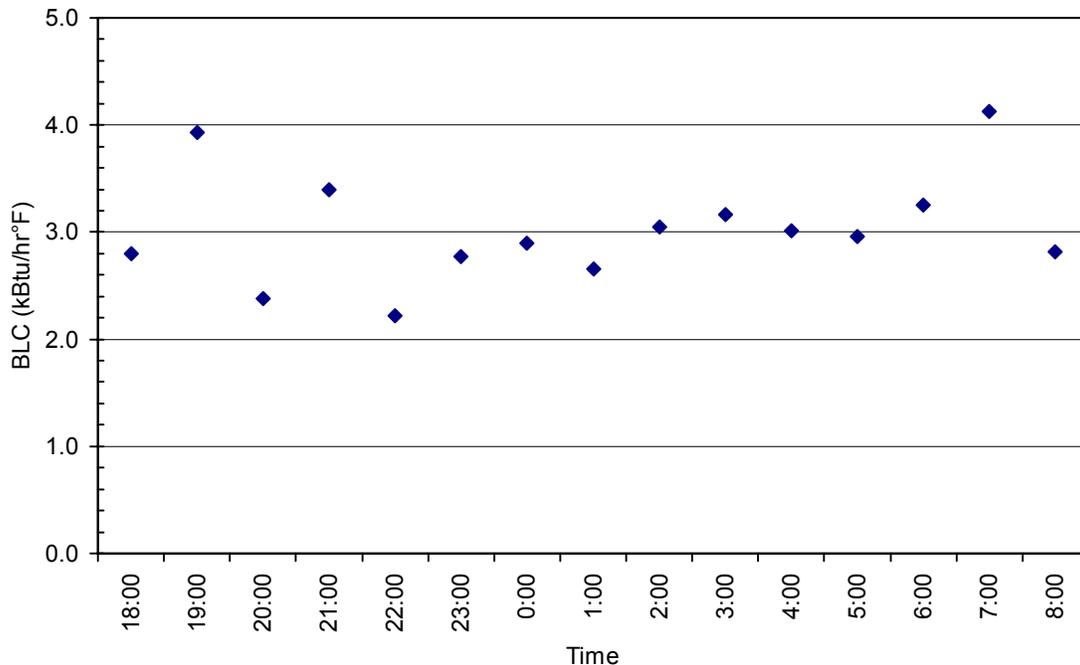
Figure 5-3 STEM results for the BLC

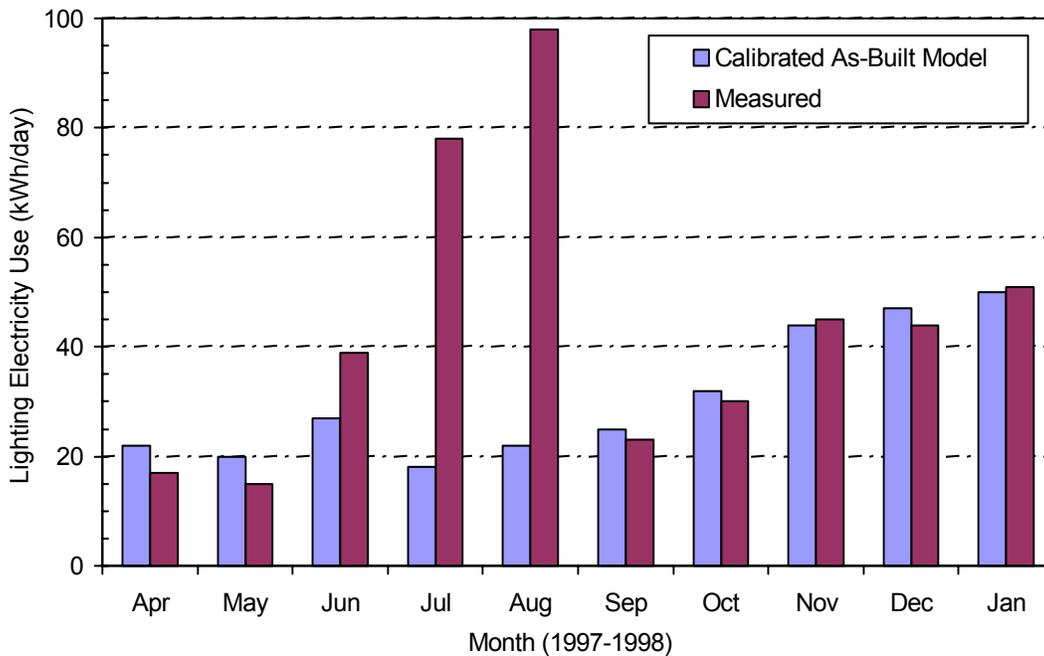
Figure 5-4 Lighting system calibration results

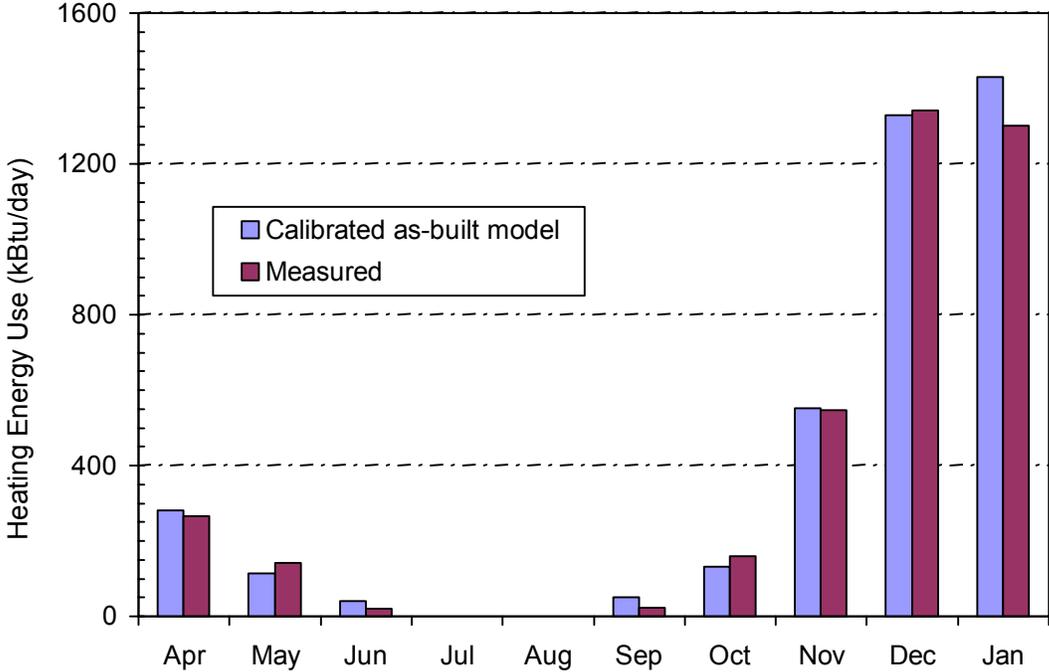
Figure 5-5 Comparison of calibrated model versus actual measurements for building heating energy

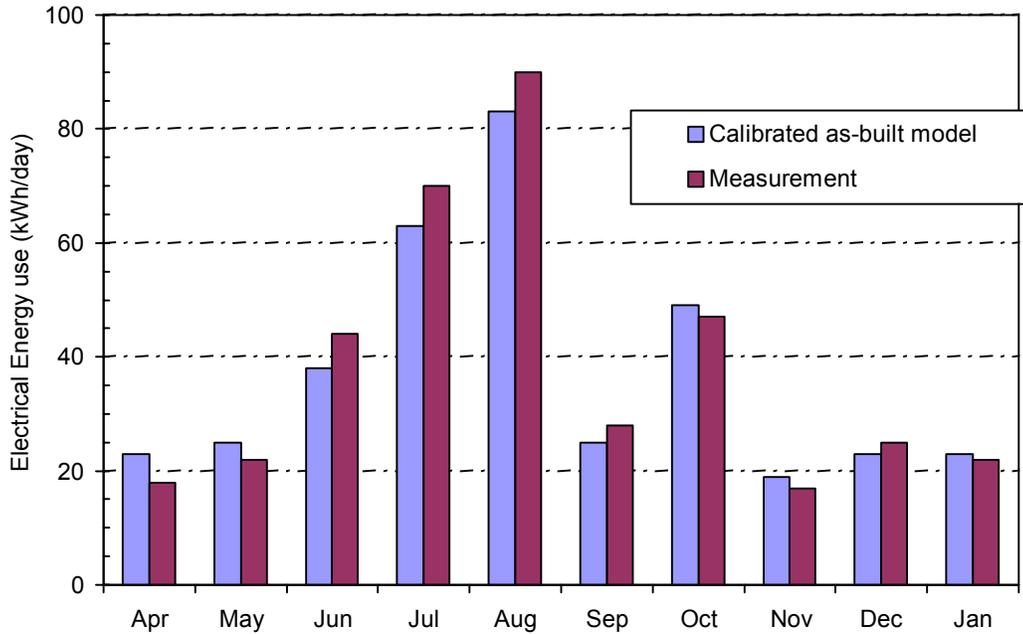
Figure 5-6 Results for HVAC system electricity energy use: calibrated model versus measurement

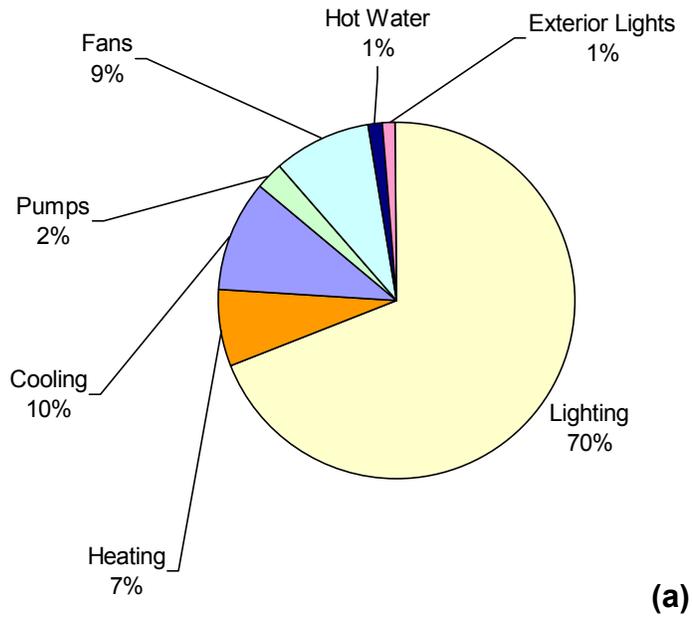
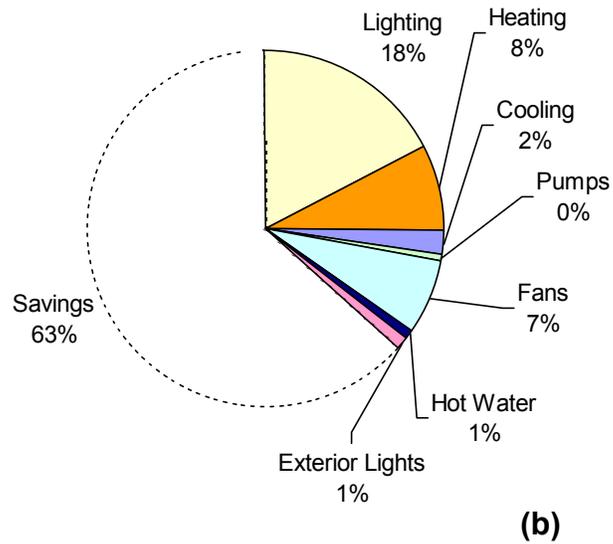
Figure 5-7 Pie charts of annual energy costs (excluding plug loads) from (a) the calibrated base-case model and (b) the calibrated as-built model

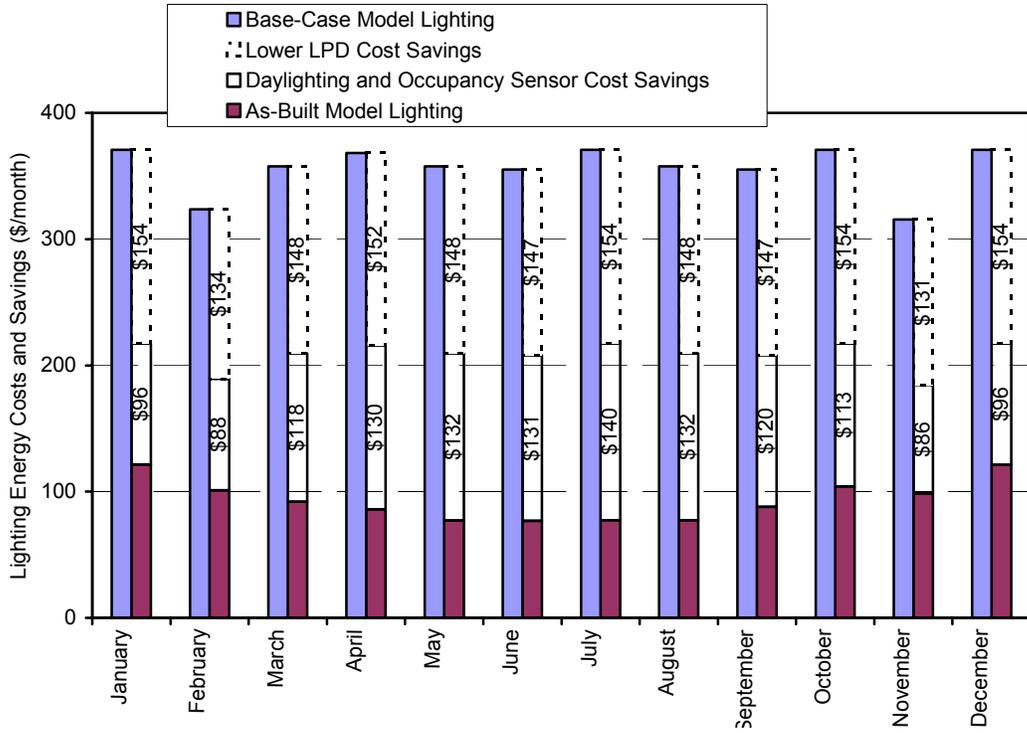
Figure 5-8 Graph of energy costs and savings for lighting by month based on a typical operating year

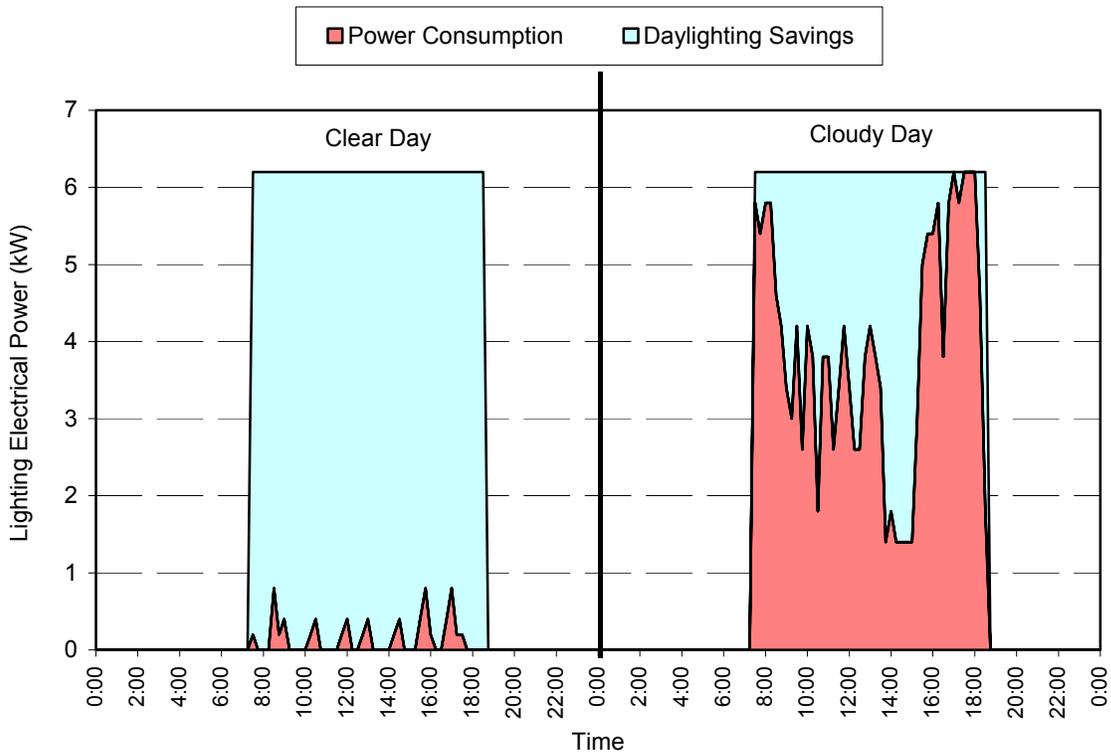
Figure 5-9 Electric lighting power consumption on typical clear day and cloudy day

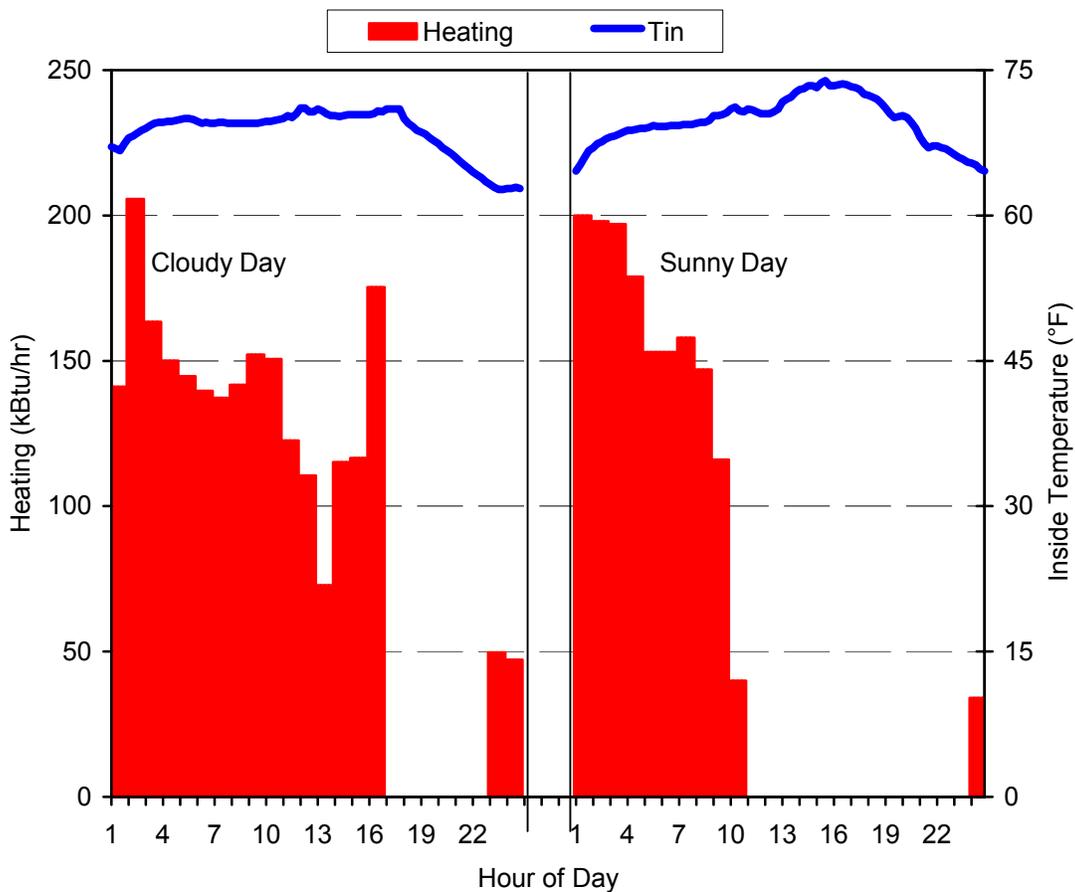
Figure 5-10 Heating loads on a cloudy day compared with heating loads on a sunny day

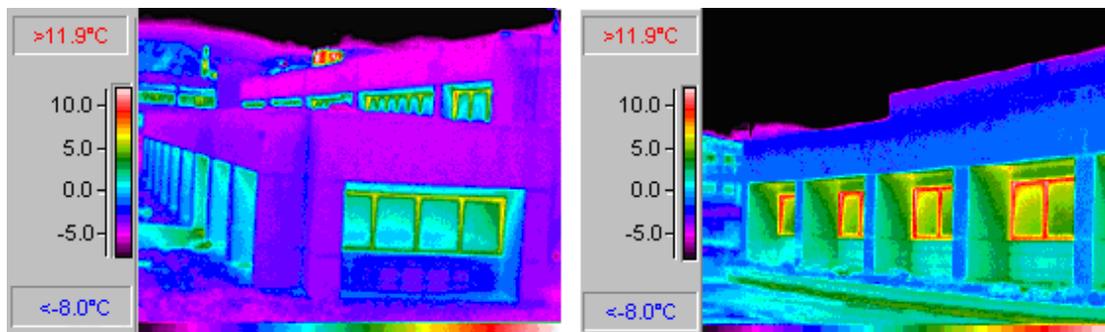
Figure 5-11 Infrared thermal images showing heat loss through window frames

After construction was completed, NREL determined that the contractor did not install thermally broken windows and doorframes. Although the design team originally agreed to include these energy-saving features, the frames that were installed were not thermally broken. Documentation indicates that the products purchased were those specified. It is not clear why the requested frames were not included in the building. At the time of construction, the marketing of energy-efficient window products led to confusion in the field; activities of the National Fenestration Rating Council has since partly remedied the problem. It is critical that door and window frames be carefully specified with resistance values and that construction management has a mechanism for evaluating such products in the field to ensure that they are installed according to design intent. Analysis of this issue is discussed in Section 5.4.1.2.

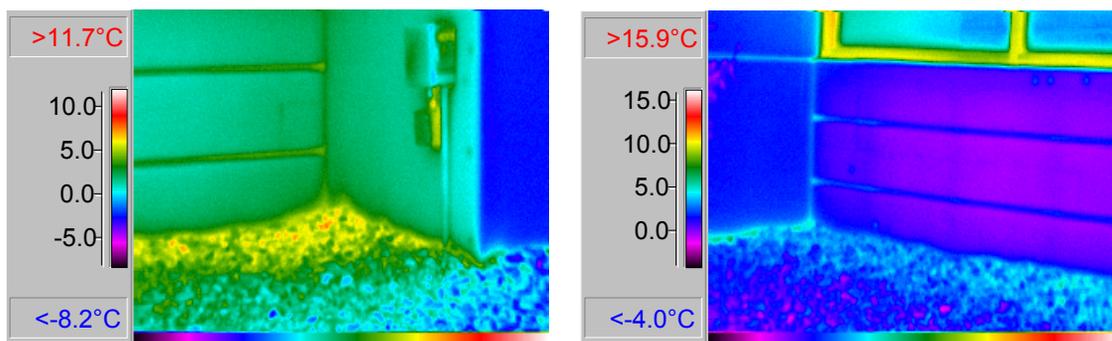
Figure 5-12 Infrared thermal images showing heat loss at the foundation

Perimeter slab insulation was specified on the inside of the foundation for ease of installation. The concept was the interior insulation would not need to be fitted around the fins and the insulation would be better protected during construction. During construction, structural concerns with the interface between the slab and the exterior walls resulted in the removal of some of this insulation. By the time the construction decision was discovered, the location had already been backfilled, making it too costly to add the insulation on the exterior of the building. Consequently, a 6-in. (15.2-cm) thermal bridge is located around the perimeter of the concrete slab. The largest impact is on thermal comfort near the perimeter of the building. Although difficult to quantify, the result is probably higher space temperatures to offset the impact of the colder floor.

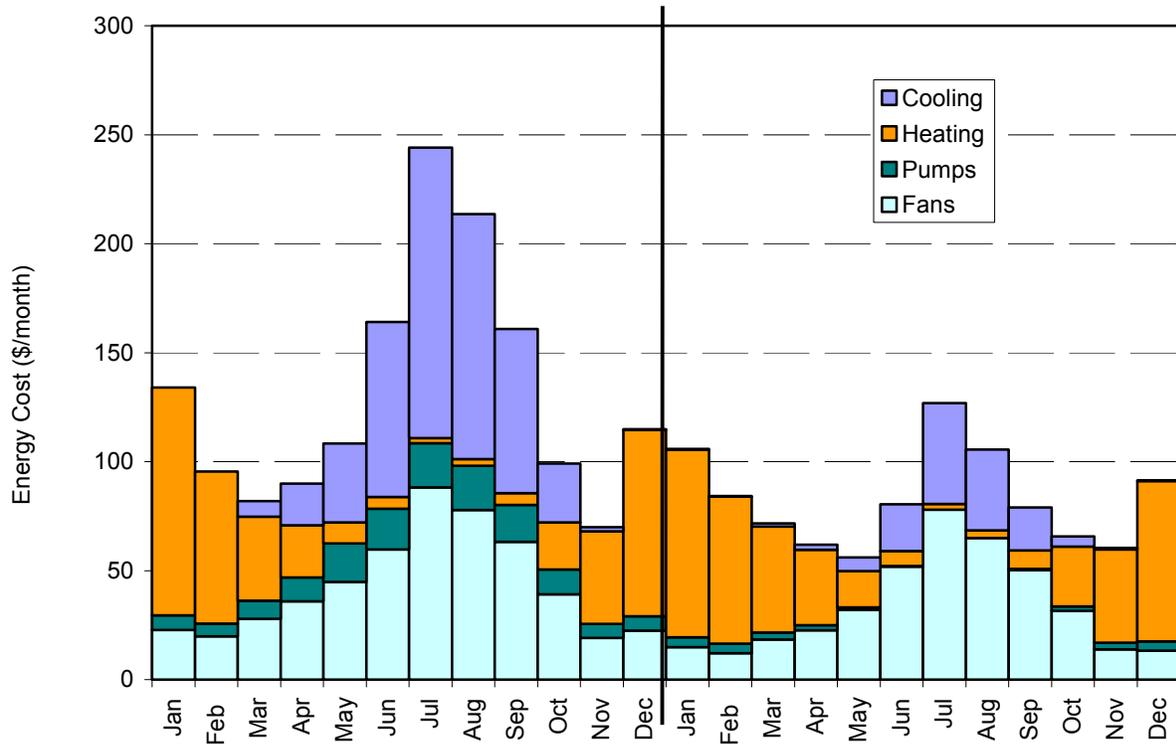
Figure 5-13 Comparison of HVAC operating costs

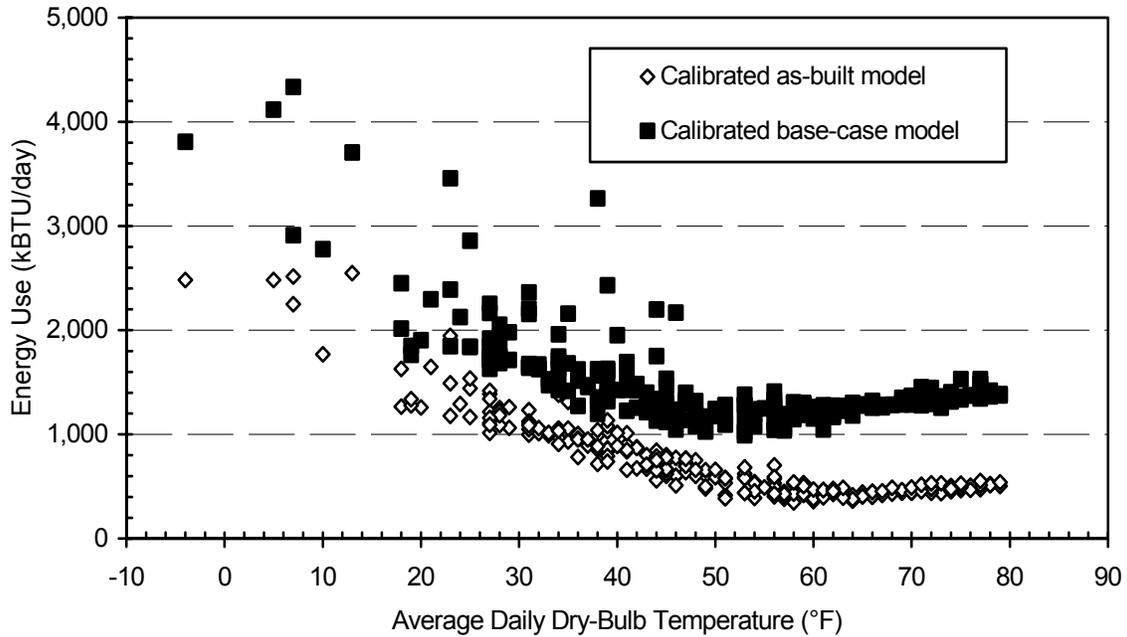
Figure 5-14 Daily energy use for heating, cooling, pumps, and fans for the TTF compared with the base-case building

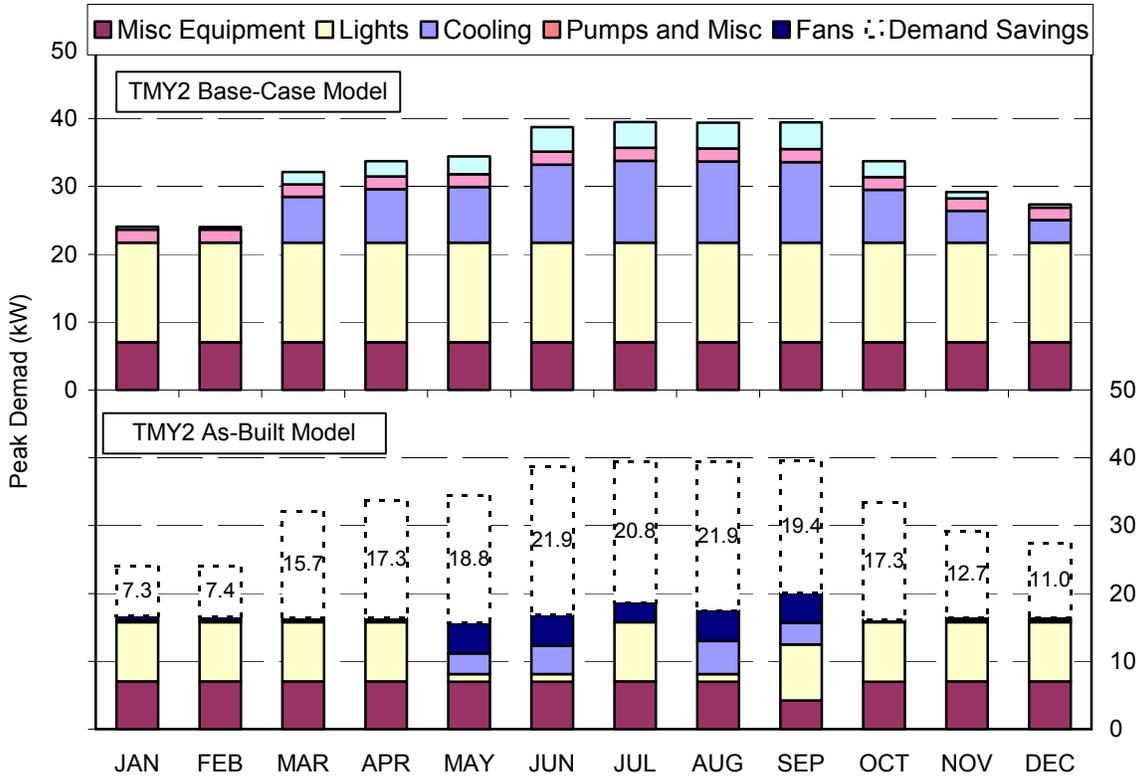
Figure 5-15 On-peak demand of as-built and base-case models

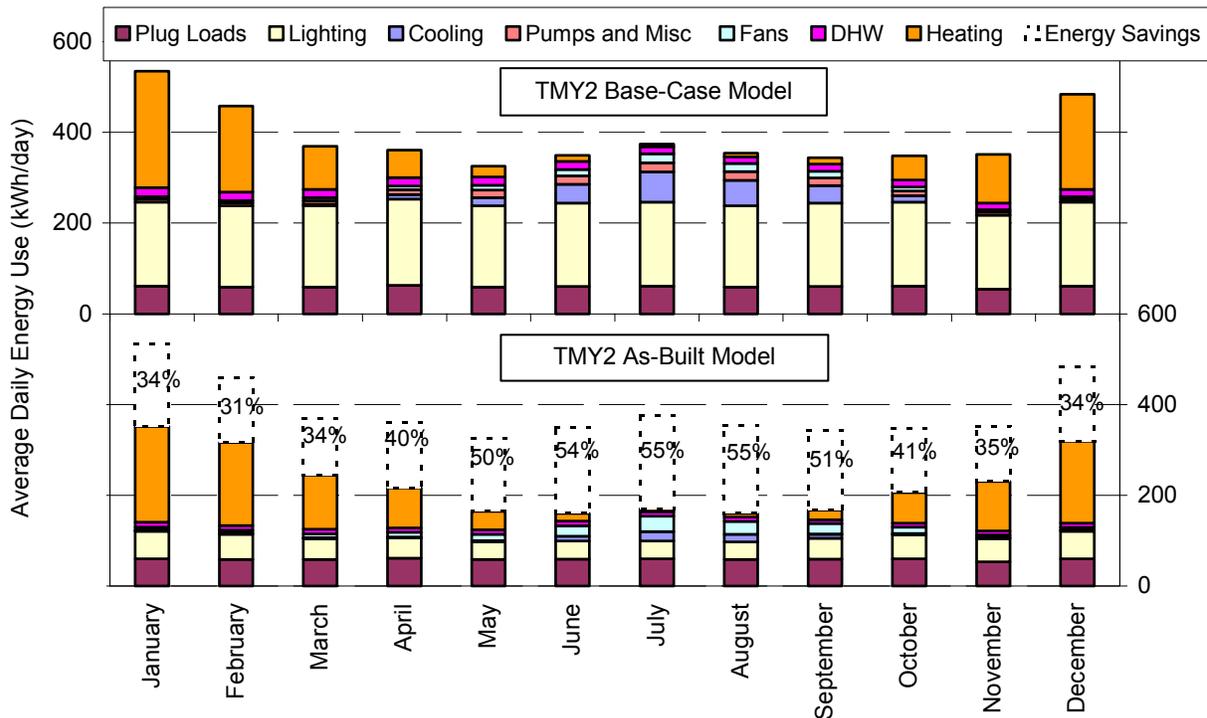
Figure 5-16 Average daily energy use from the calibrated base-case model and the calibrated as-built model

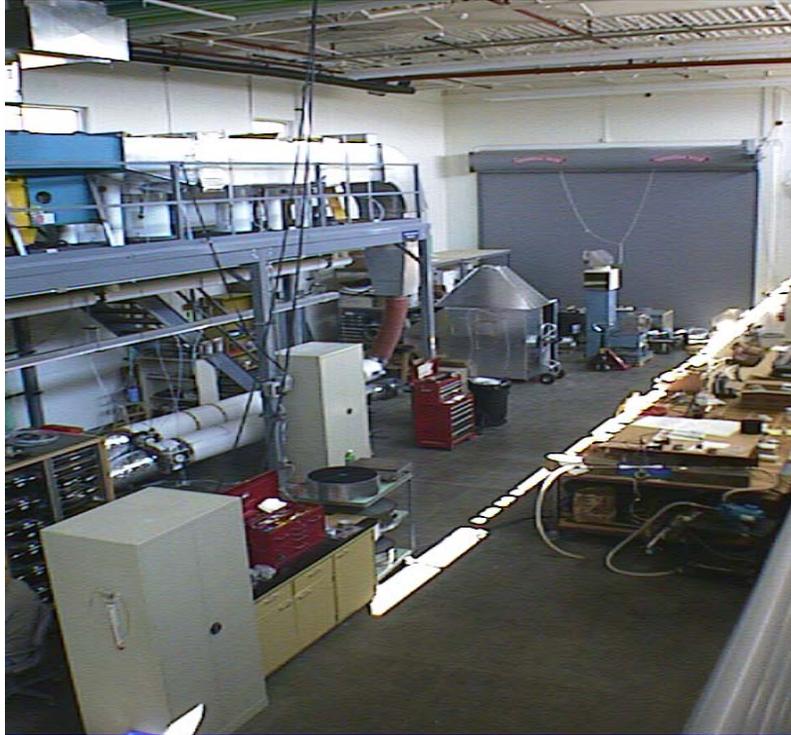
Figure 6-4 High-bay laboratory spaces illuminated by daylight (note direct gain stripe)

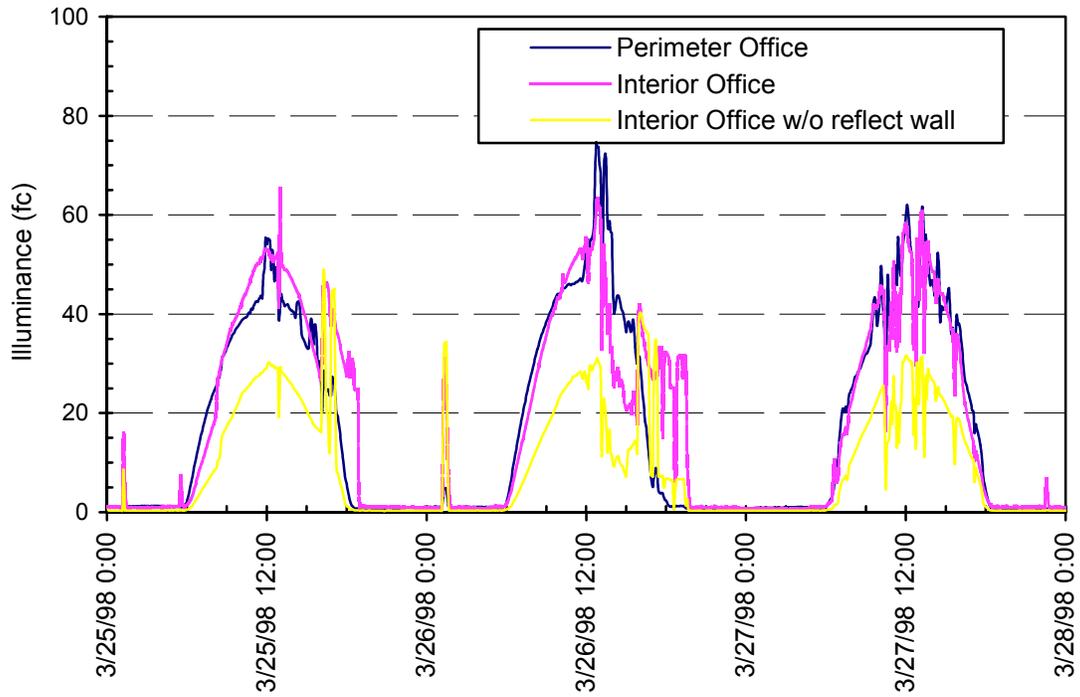
Figure 6-5 Office space photometric results: spring

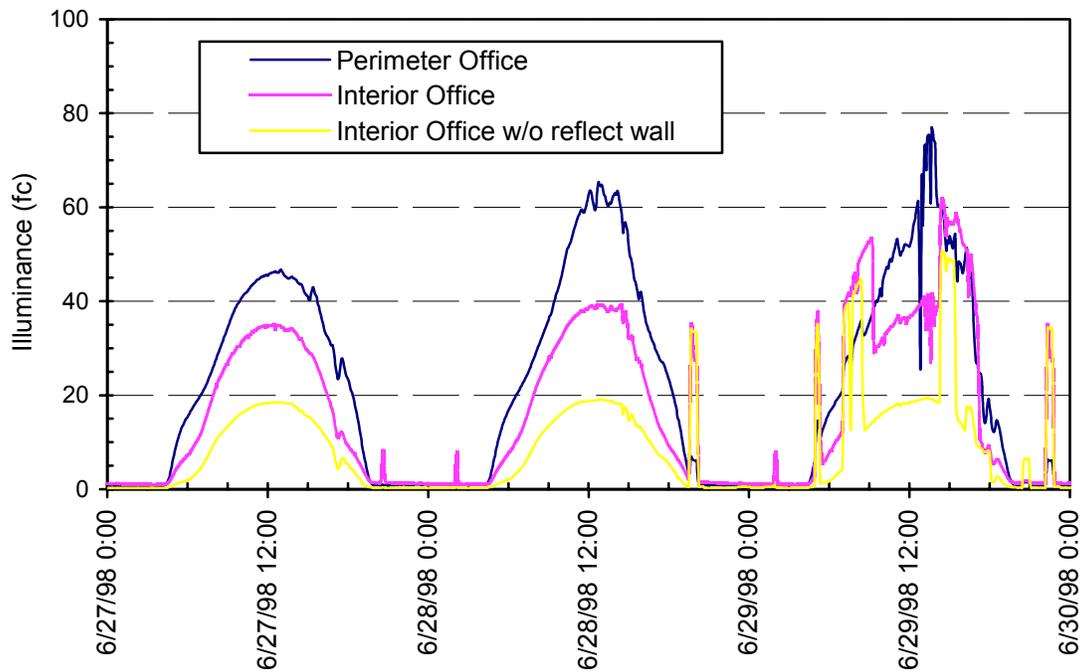
Figure 6-6 Office space photometric results: summer

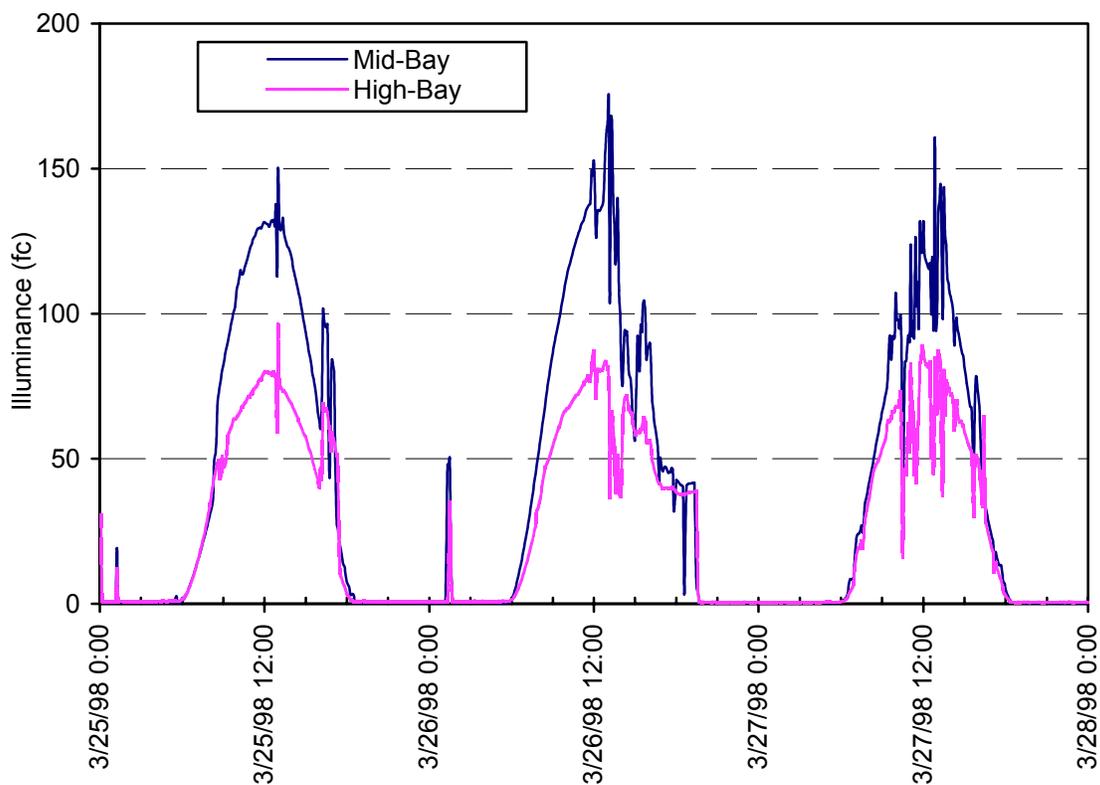
Figure 6-7 Mid-bay and high-bay laboratory photometric results: spring

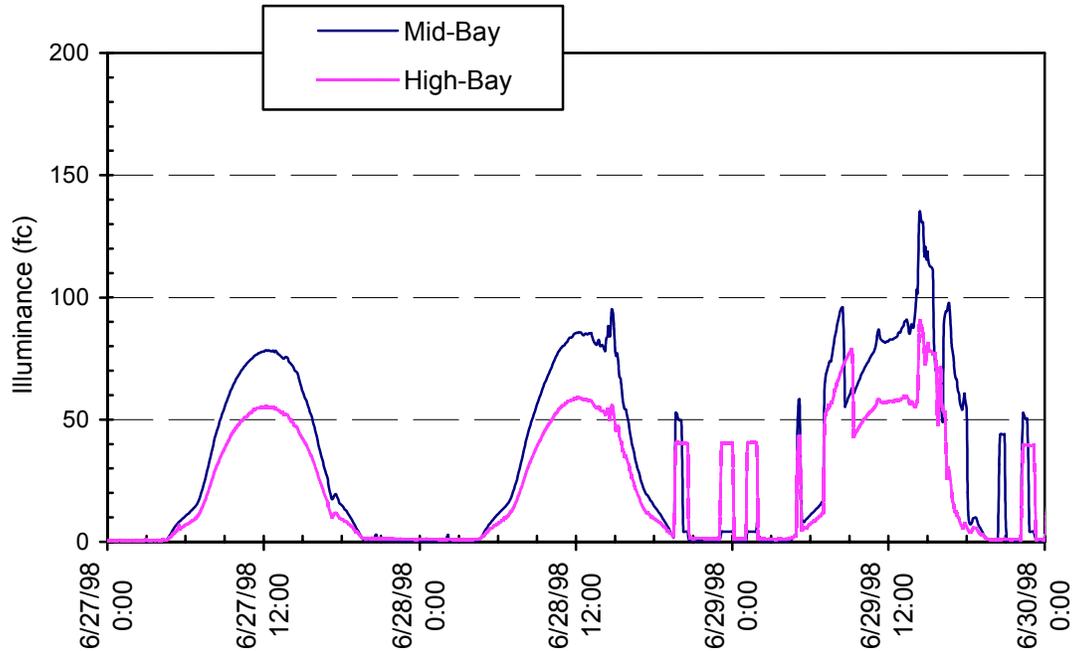
Figure 6-8 Mid-bay and high-bay laboratory photometric results: summer

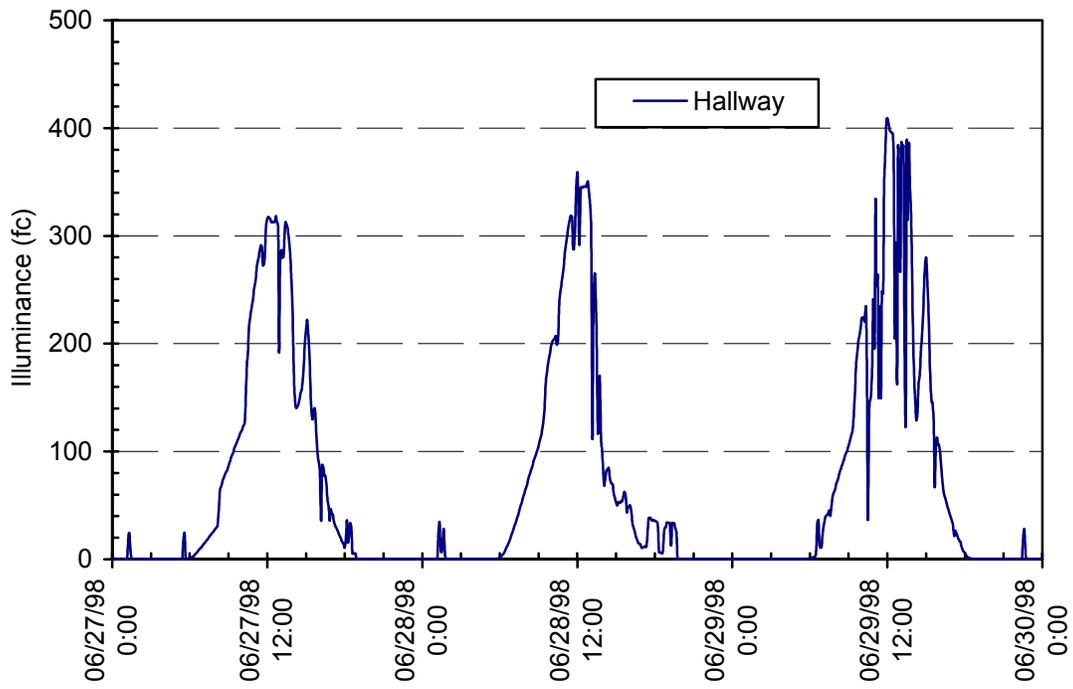
Figure 6-9 Hallway photometric results: spring

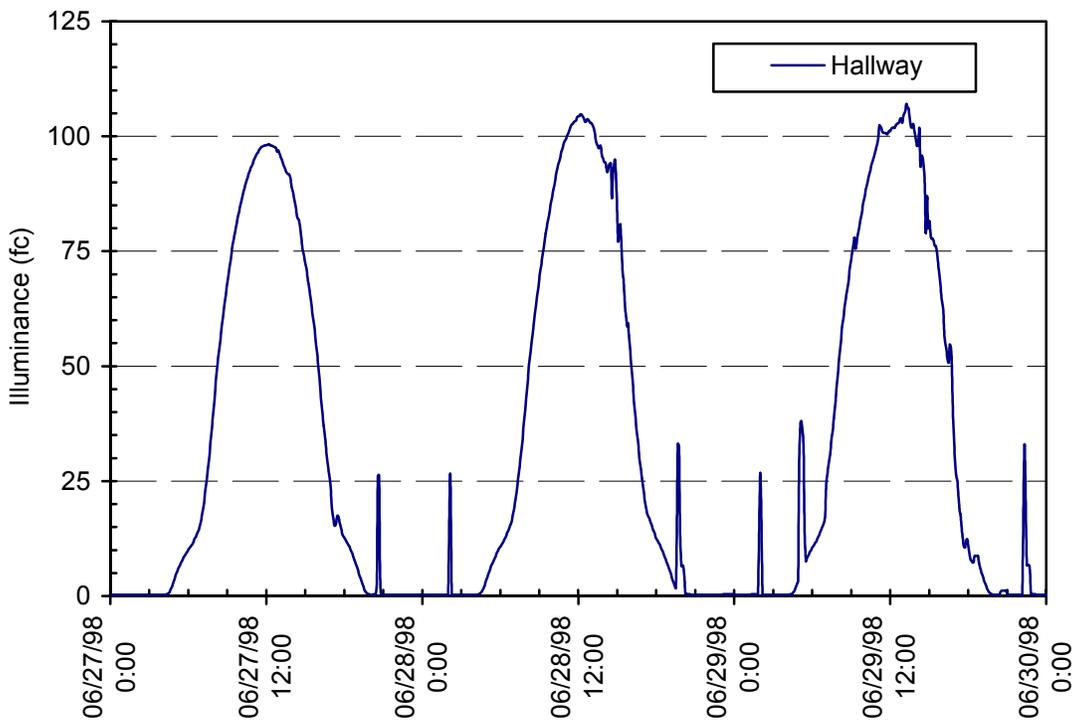
Figure 6-10 Hallway photometric results: summer

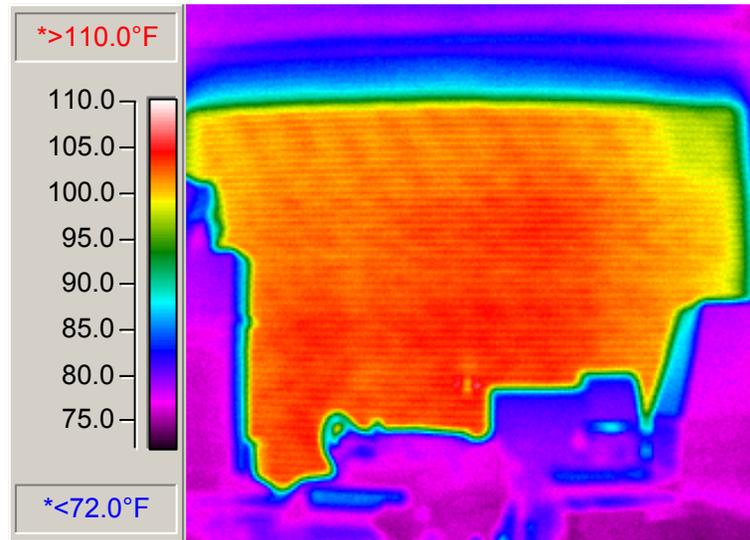
Figure 6-11 High-bay insulated roll-up door thermographic results

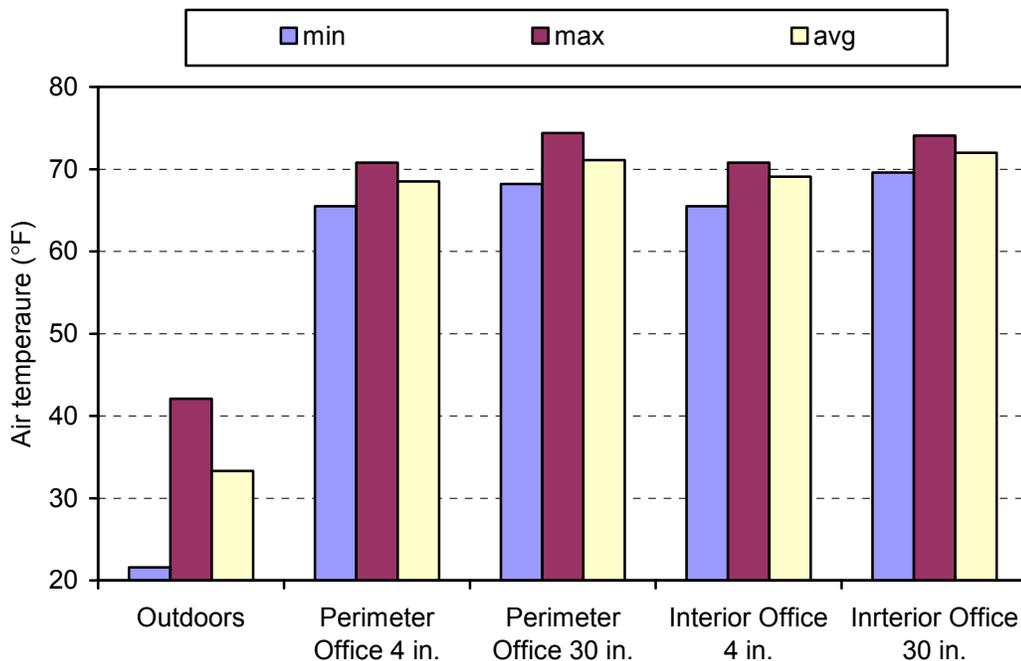
Figure 6-12 Comfort results for vertical temperatures during heating season
